**Flood Control Project Maintenance
Levee Inspections**

Spring 2011 Levee Inspection Results

Butte County Public Works

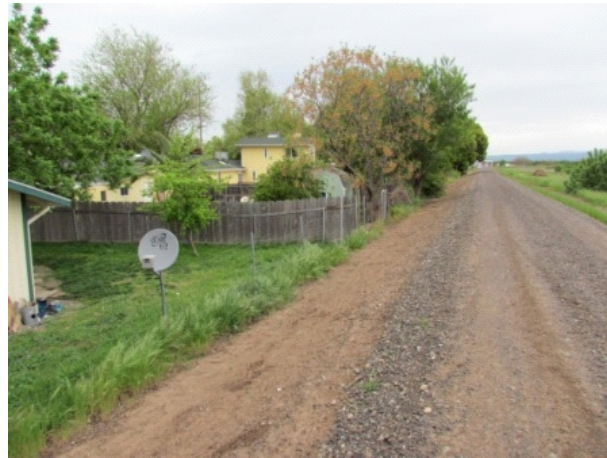
Levee Mile Report Line	2
Start Levee Mile	2.06
End Levee Mile	2.10
Location	Land Side
Category	Earthen Levee
Item	Encroachments

View of the fences along the L/S toe.

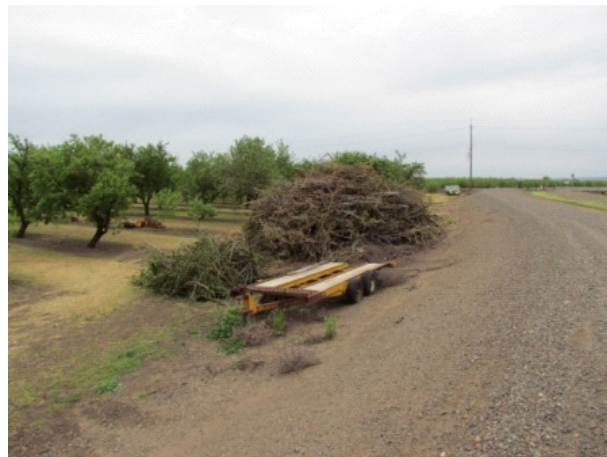
Levee Mile Report Line	6
Start Levee Mile	3.00
End Levee Mile	3.00
Location	Land Side
Category	Earthen Levee
Item	Encroachments

View of the pruning pile along the L/S toe.

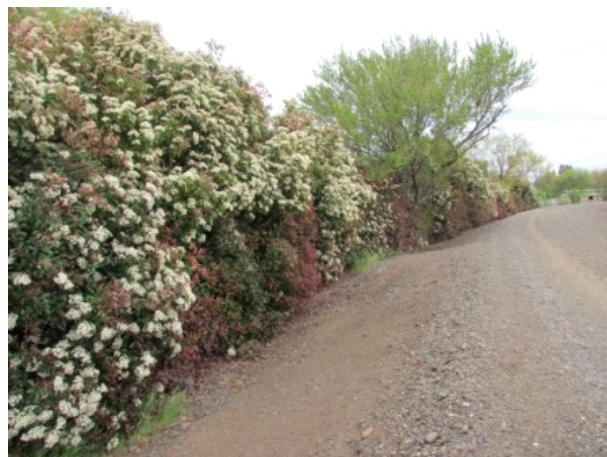
Levee Mile Report Line	13
Start Levee Mile	6.12
End Levee Mile	6.16
Location	Land Side
Category	Earthen Levee
Item	Trim / Thin Trees

View of the trees along the L/S toe.

13	6.12	6.16	Earthen Levee	Trim / Thin Trees	LS		Trim trees to at least five feet above ground level.	39.793370 ° -121.887312 °	39.794052 ° -121.887125 °	9 Y	
14	6.24	6.28	Earthen Levee	Trim / Thin Trees	LS	M	Trim trees to at least five feet above ground level.	39.794867 ° -121.886398 °	39.795157 ° -121.885893 °	10 Y

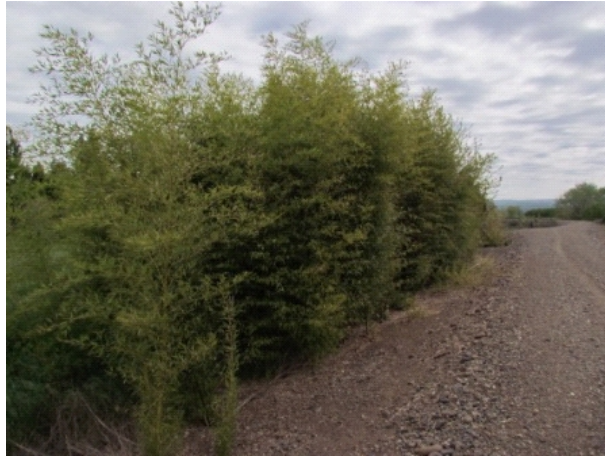
Levee Mile Report Line	14
Start Levee Mile	6.24
End Levee Mile	6.28
Location	Land Side
Category	Earthen Levee
Item	Trim / Thin Trees

View of the trees along the L/S toe.

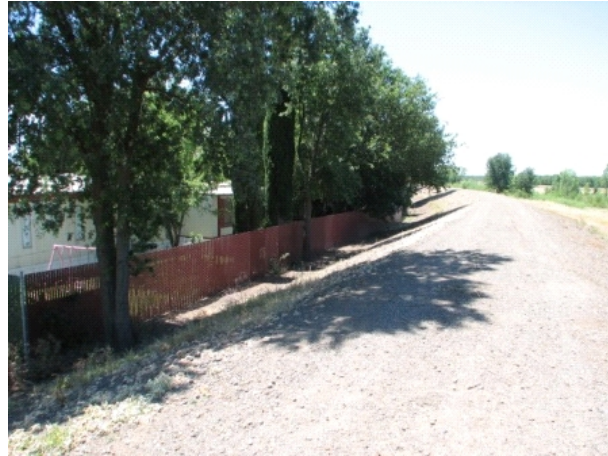
Levee Mile Report Line	1
Start Levee Mile	1.58
End Levee Mile	1.90
Location	Land Side
Category	Earthen Levee
Item	Encroachments
View of the fence along the landside toe of the levee.	
rduffey_s_20110228_062.jpg

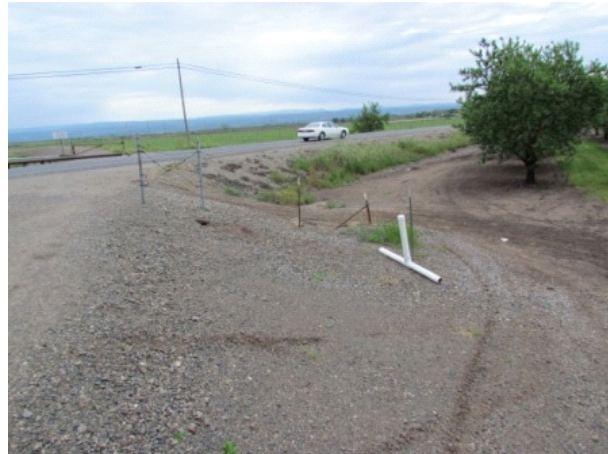
Levee Mile Report Line	2
Start Levee Mile	4.46
End Levee Mile	4.46
Location	Land Side
Category	Earthen Levee
Item	Animal Control
View of the rodents burrows along L/S slope.	
rduffey_s_20110420_266.jpg

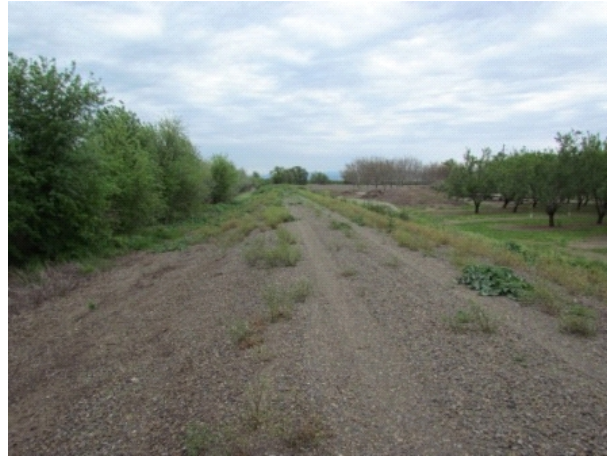
Levee Mile Report Line	1
Start Levee Mile	0.00
End Levee Mile	0.30
Location	Land Side
Category	Earthen Levee
Item	Vegetation

View of the clean levee.

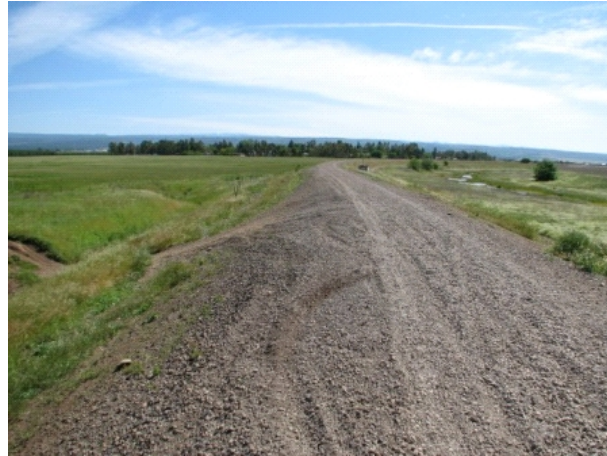
Levee Mile Report Line	1
Start Levee Mile	0.06
End Levee Mile	0.06
Location	Water Side
Category	Earthen Levee
Item	Slope Stability

View of the motorcycle erosion on the landside slope of the levee.

LMR No.	Levee Mile		Category	Item	* Location	** Rating	Action/Comment	GPS Latitude/Longitude		Issue No. Photo
	Start	End						Start	End	
1	0.06	0.06	Earthen Levee	Slope Stability	WS	M	Repair the levee slope damaged by vehicle traffic and prevent access where possible.	39.786068 ° -121.881828 °	39.786068 ° -121.881828 °	3 Y
2	1.77	1.77	Earthen Levee	Vegetation	WS	A	Control annual grass and weeds on the levee slopes and easements.	39.779478 ° -121.853483 °	39.779478 ° -121.853483 °	1 Y

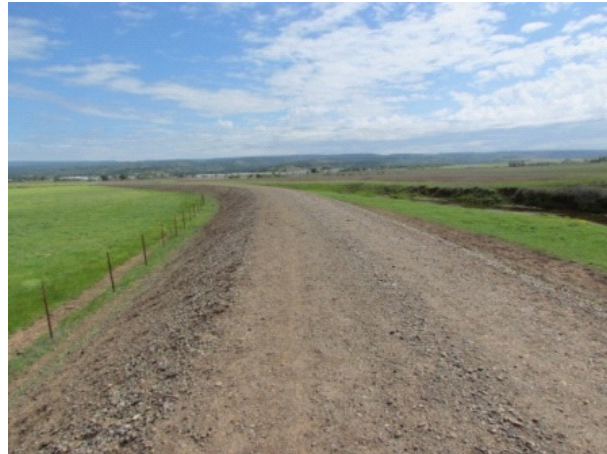
Levee Mile Report Line	2
Start Levee Mile	1.77
End Levee Mile	1.77
Location	Water Side
Category	Earthen Levee
Item	Vegetation

View of levee clear of vegetation.

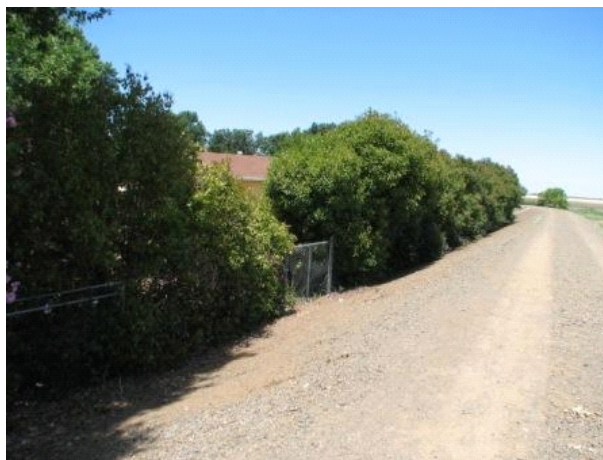
Levee Mile Report Line	1
Start Levee Mile	0.98
End Levee Mile	1.05
Location	Land Side
Category	Earthen Levee
Item	Encroachments

View of the fence and trees along the landside toe of the levee.

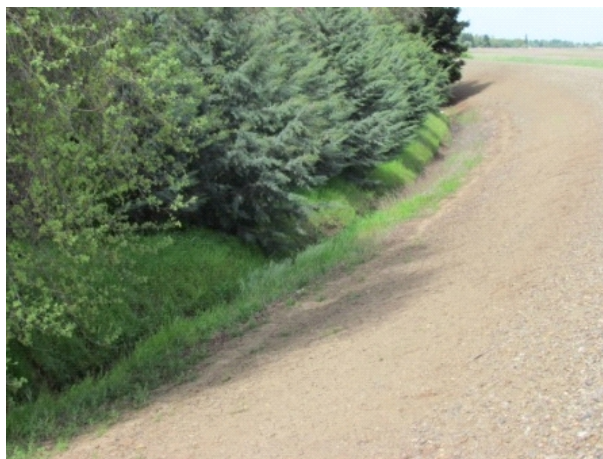
Levee Mile Report Line	3
Start Levee Mile	1.32
End Levee Mile	1.40
Location	Land Side
Category	Earthen Levee
Item	Encroachments

View of AG ditch at the L/S toe.

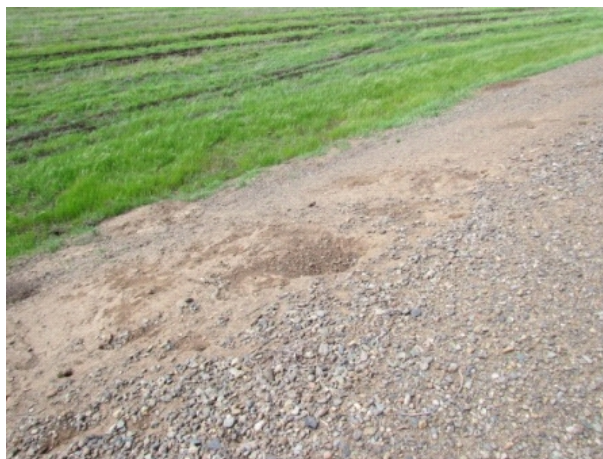
Levee Mile Report Line	4
Start Levee Mile	1.76
End Levee Mile	1.76
Location	Land Side
Category	Earthen Levee
Item	Animal Control

View of rodents burrows on the L/S slope.

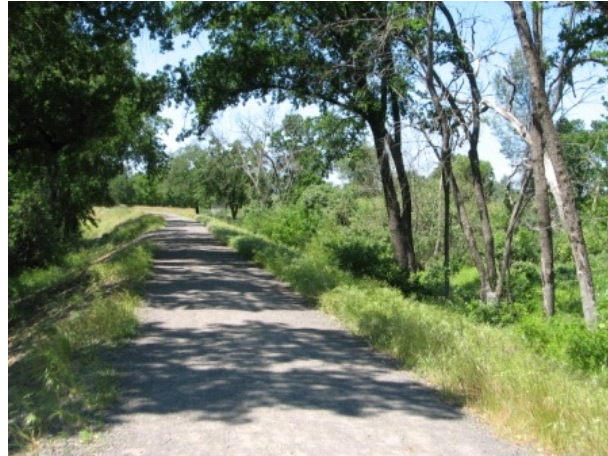
Levee Mile Report Line	1
Start Levee Mile	0.22
End Levee Mile	0.45
Location	Water Side
Category	Earthen Levee
Item	Vegetation

View of the noxious weeds on both slopes of the levee.

LMR No.	Levee Mile		Category	Item	* Location	** Rating	Action/Comment	GPS Latitude/Longitude		Issue No. Photo
	Start	End						Start	End	
1	0.22	0.45	Earthen Levee	Vegetation	WS	M	Remove the wild growth other than native grasses from the levee slopes.	39.761921 ° -121.792929 °	39.761110 ° -121.796950 °	2 Y
2	0.22	0.45	Earthen Levee	Vegetation	LS	M	Remove the wild growth other than native grasses from the levee slopes.	39.761920 ° -121.792930 °	39.761110 ° -121.796951 °	1 Y

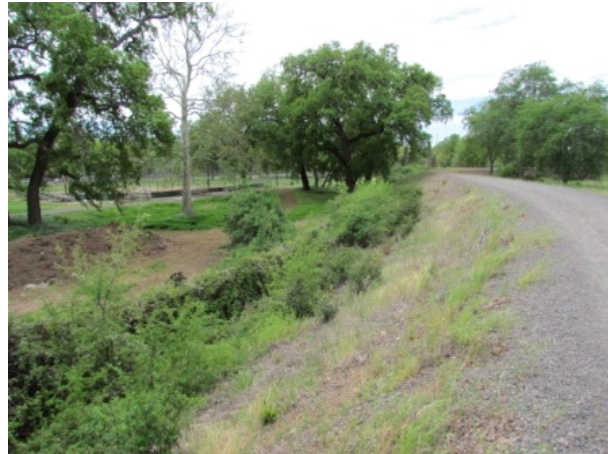
Levee Mile Report Line	2
Start Levee Mile	0.22
End Levee Mile	0.45
Location	Land Side
Category	Earthen Levee
Item	Vegetation

View of vegetation on the slope & toe.
